Fact Sheet August 2013

# The Case for Reinvesting in the Pohick Creek Watershed Site 2

Pohick Creek Watershed Project Site 2 is known to local residents as Lake Barton. The dam was rehabilitated through a collaborative effort between NRCS, Fairfax County, and the Northern Virginia Soil and Water Conservation District to reduce the risk of flooding to downstream residents and commuters and help the county comply with current dam design and safety standards.

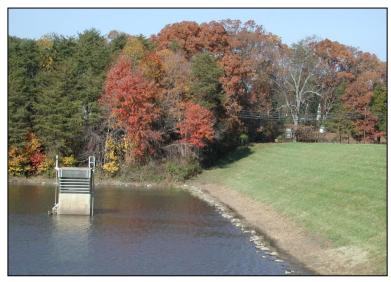
Pohick Site 2, known as Lake Barton, protects homes, businesses, four major roads and several railroad bridges from flooding.

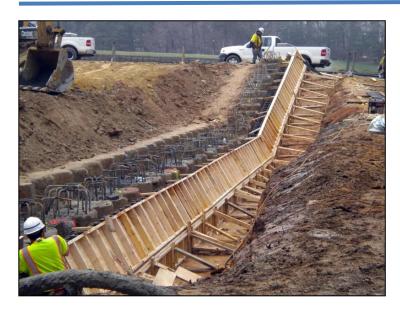
(Left) A secant pile wall was installed to increase the stability of the auxiliary spillway.

(Below) The site was graded and seeded to restore the appearance to its original condition.

Two concrete cutoff walls were installed to stabilize the spillway. As a result of this project, the dam will continue to provide multiple benefits to the residents of this community.

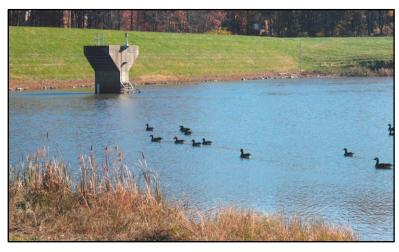
Ducks head toward riser at Pohick Site 2.
